TECHNICAL REPORT ARCCB-TR-99010

**ANALYSIS OF A PISTON EXPERIENCING
ENVIRONMENTALLY-ASSISTED CRACKING
AS A RESULT OF COMPRESSIVE OVERLOADING**

JUNE 1999

**US ARMY ARMAMENT RESEARCH,
DEVELOPMENT AND ENGINEERING CENTER
CLOSE COMBAT ARMAMENTS CENTER
BENÉT LABORATORIES
WATERVLIET, N.Y. 12189-4050**

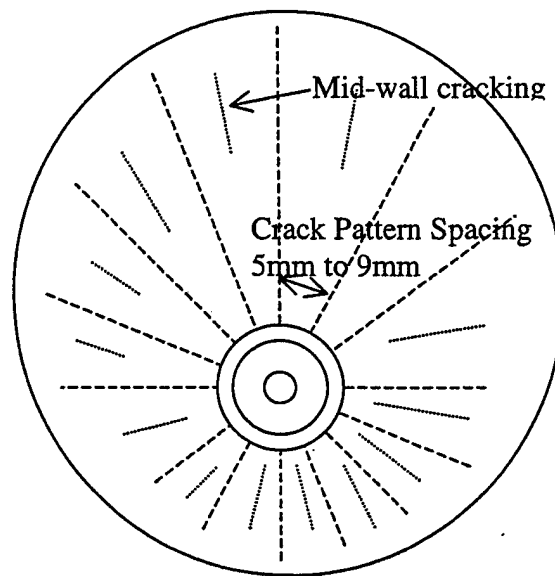
In August 1997, testing was conducted of a piston utilized in the seal of a closed-ended pressure vessel. Testing included 100 loading cycles, at pressures ranging from 69 MPa to 414 MPa. Upon completion of the test, the component was disassembled, cleaned, and inspected. Although no pressure losses were observed during the test, it was noticed that cracking of the Maraging 200 steel piston had occurred (Figure 1). Cracking was not observed during testing because cleaning of the system was strictly forbidden. The cracking pattern emanated in a radial fashion around the piston, yet none of the cracks broke through the thickness of the piston. Cracks ranged in length from barely noticeable, to approximately 20-mm in length. Cracking was also observed at many locations approximately half the distance between the center of the piston and the outside diameter. In some cases, cracks that started in the center of the piston appeared to "link up" with the cracks that started at the midpoint between the center and the outside diameter. There was also a characteristic ripple where the cracked surfaces protruded upward, producing an uneven texture on the top surface of the piston. The crack pattern appeared relatively evenly spaced, with a crack spacing of approximately 5-mm to 9-mm.

Figure 1. Radial cracking pattern on piston face.

A closer look at the finite element model indicated that the piston did deform into a "dish-like" shape during the loading process. The resultant stresses were compressive on the top surface, exceeding the compressive yield strength of the material, and were predicted to be approximately 1600 MPa.

These conclusions also suggest that a suitable method to prevent hydrogen cracking was to create a barrier to prevent the hydrogen from contacting the highly susceptible, highly stressed base material.

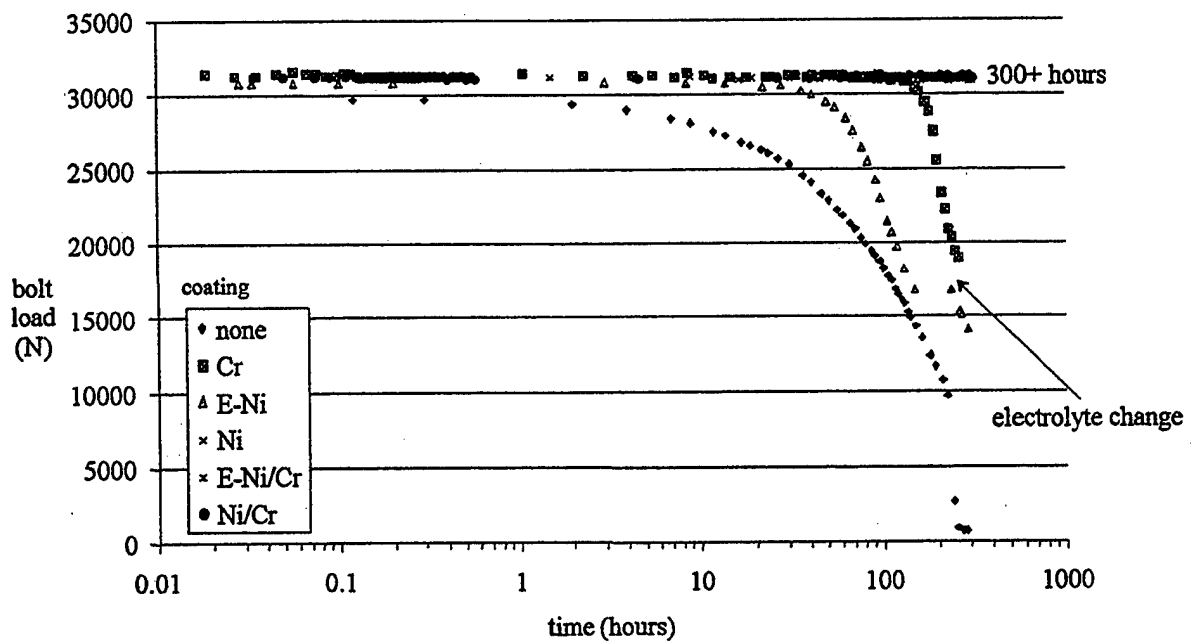
Figure 4 clearly highlights the resistance that each of the coatings provides to the Maraging 200 base material. We can see that the Maraging 200 material with no coating provided approximately one hour incubation time, followed by a decreasing load as monitored by the instrumented bolt. After approximately 250 hours of exposure, the cracking had reached an apparent threshold value, and no further decrease in load was observed. The specimen with the electroless nickel (E-Ni) protective coating provided approximately 30 hours of protection, and rapid cracking of the underlying base material resulted. In this test, after approximately 150 hours of exposure, the cracking appeared to arrest. Cracking immediately resumed after the electrolyte was changed. We believe that the electrolyte had become depleted, or because the electrolyte is hygroscopic, it may have absorbed enough moisture to severely compromise the pH of the acid. The specimen that was protected with the chromium coating (Cr) provided approximately 150 hours of protection, and was followed by rapid cracking of the base material. The specimens protected with the electroplated nickel (Ni), electroplated nickel and chromium (Ni/Cr), and electroless nickel and chromium (E-Ni/Cr) all withstood the 300 hours of exposure with no degradation of the base material.

Figure 4. Environmental cracking resistance of Maraging 200.

3. An electroplated nickel coating will prevent hydrogen from cracking susceptible materials such as high strength A723 steel and Maraging 200. The electroless nickel coating did increase the base material's resistance to hydrogen cracking. However, it was not as effective as the electroplated nickel.

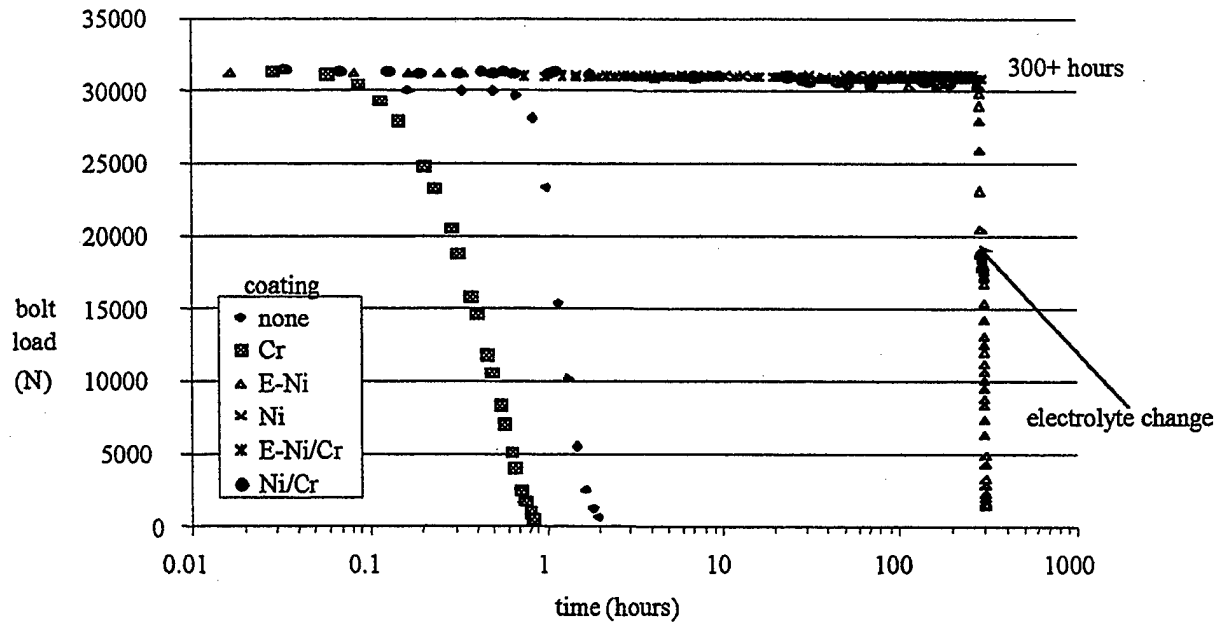
Figure 5 shows results of the tests on the 1300 MPa A723 steel. The first thing to note is that the A723 steel with no protective coating provided less than one hour of incubation time, and cracking had proceeded to the threshold in less than two hours. The chromium coated specimen provided approximately 0.1 hour of incubation time and had proceeded to the threshold in less than one hour. We believe this is a direct result of microcracking, which is often observed in chromium plating. This microcracking acts as crack initiation sites and rapidly accelerates the incubation time. The specimen coated with electroless nickel provided approximately 280 hours of incubation time, at which time the specimen began shedding load. At approximately 290 hours of exposure, the cracking arrested and an electrolyte change was performed. Cracking immediately resumed and at 300 hours, the specimen had attained the threshold. The specimens with electroplated nickel, electroplated nickel and chromium, and electroless nickel and chromium attained the 300 hours of exposure with no cracking and no shedding of load.

Figure 5. Environmental cracking resistance of A723 steel.
